Heritage Impact Assessment Update
Proposed Humber College Welcome Centre
Colonel Samuel Smith Park
City of Toronto, Ontario

July 2011 (Updated September 2014)

Heritage Impact Assessment Update

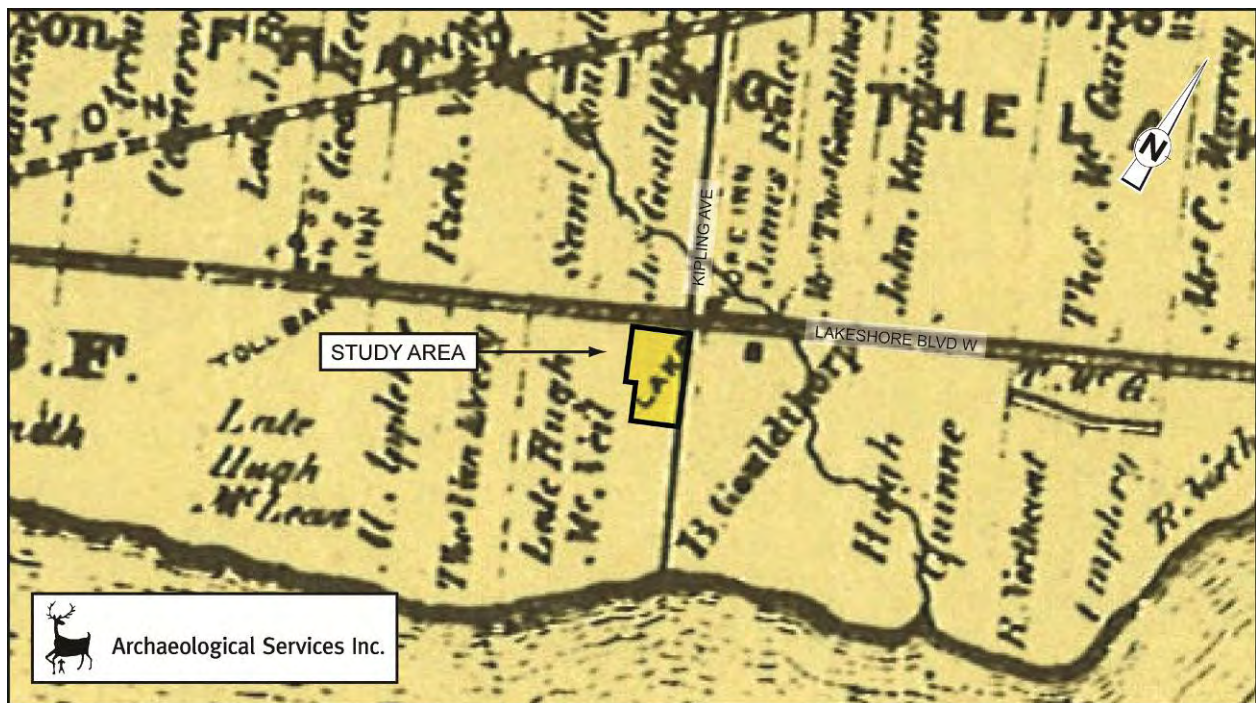
Figure 5: The subject property overlaid on the 1860 Tremaine's Map of the Township of York
Base Map: *Tremaine's Map of the County of York, Canada West* (Tremaine 1860)

Historic mapping for this time period dates to 1860 and 1878 (Figures 5 and 6). By 1860, the date of publication of the *Tremaine Map*, the area surrounding the study area had become settled, with Kingston Road (now Lakeshore Boulevard), located to the north, the Toronto Western Railway located further north, and the Village of Mimico located to the northeast.

The study area is listed under the ownership of Mr. Leslie Hugh McNeil. There are no historical features located within the study area.

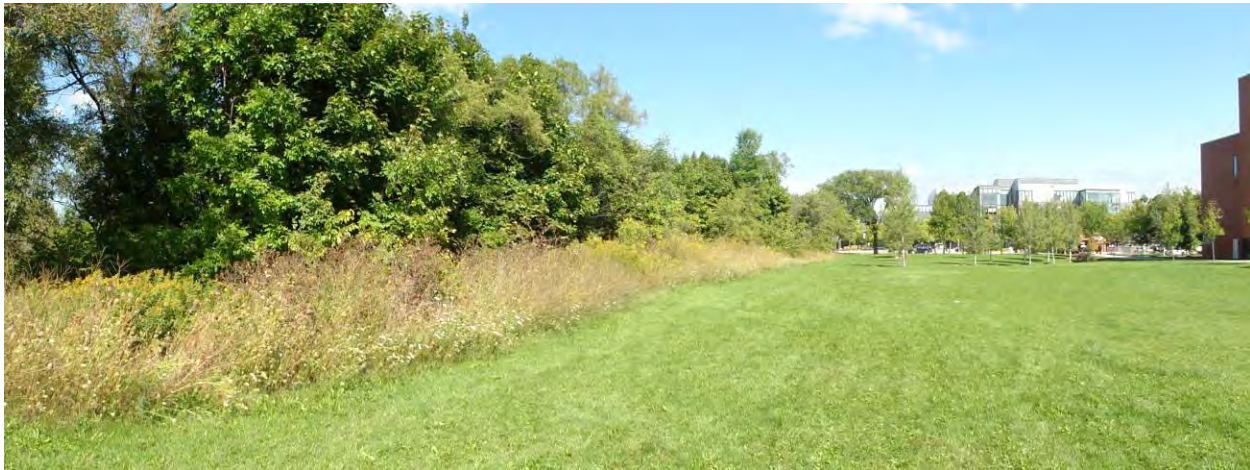
This portion of the wooded area is bounded by the open, grassy space north of Father John Redmond Catholic Secondary School (Plate 1), the athletic track, the east-west axial path (Plate 2) and the setback along the east side of Colonel Samuel Smith Park Drive (Plate 3). It is smaller than the northern section, covering an area slightly less than 100 metres (east west) and not more than 75 metres north-south. The tree cover in this area is densest around the edges, thinning out to scrub vegetation within a grassy meadow area in the interior space (Plate 4). In this section of the wooded area, the apple trees are concentrated in the northeast corner and along the northern edge. The southern areas (particularly along the south and west edges) are comprised of a number of mature deciduous species (Plate 5). Among these mature trees are a number of willow trees (Plate 6), which are concentrated along the west side of the historic orchard area along the above-ground alignment of North Creek (Plate 7). North Creek runs nearly the length of the south half of the wooded area, appearing out of a culvert underneath the east-west axial path where it continues within an established stream bed until just before the southwest corner of the orchard where it is once more channelled underground. At the time of the 2014 field visit the stream was not carrying any water and was largely obscured by vegetation (Plate 8).

Plate 1: East-northeast view of the southern edge of the orchard. Note the open green space associated with Father John Redmond Catholic Secondary School. (Photo taken in 2014)

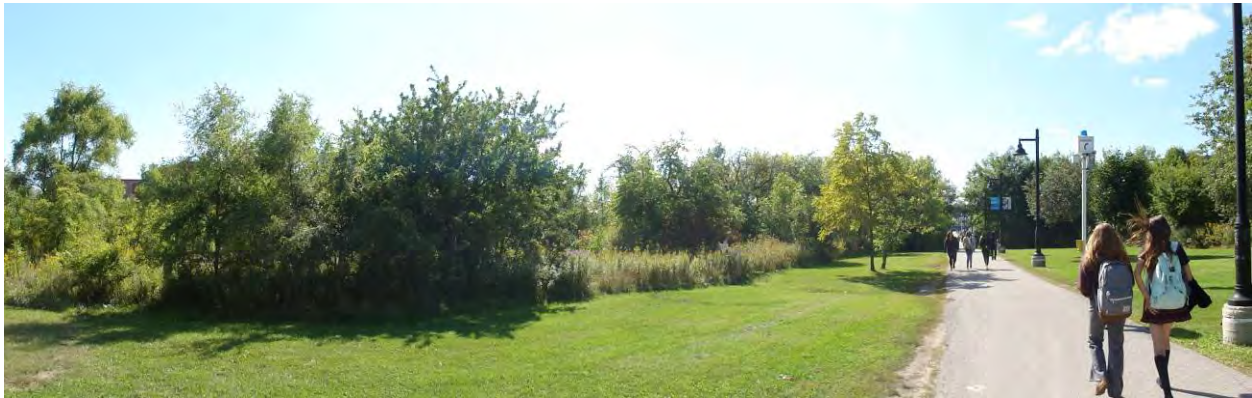
Plate 2: South-southwest from the east-west axial path. Note the cluster of apple trees on the left, south of the open grassy area. (Photo taken in 2014)

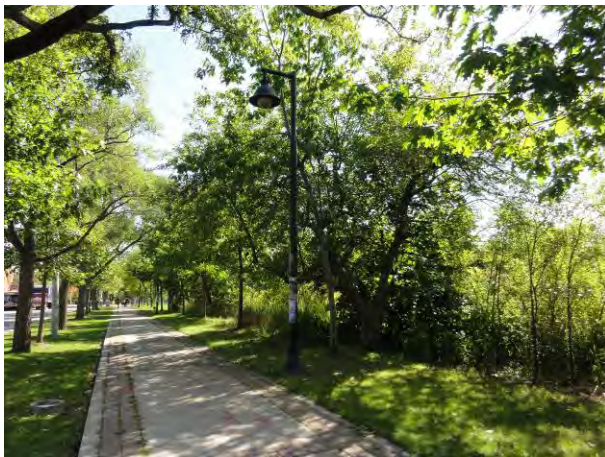
Plate 3: South-southeast view along Colonel Samuel Smith Park Drive. Note the single apple tree on the right. (Photo taken in 2014)

Although there are some individual apple trees found within this area (Plates 3, 4, and 9) that are in situ remnants of the apple orchard; it is the groupings of apple trees that are most significant in this area. The original orchard alignment is clearly visible within the eastern half of the southern section and particularly along the north edge where the orchard plantings have been retained (Plates 2 and 9). Here, a number of the extant apple trees are found within their early/original rows. A review of the aerial photographs (particularly the 1910 and 1950 photos) reveals that the orchards aligned north-south and the fields, along Lakeshore Boulevard West, were oriented east-west. As well, a review of contemporary aerial photos show that the remnants of the access road to the marina are still visible cutting on an angle northeast from the southwest corner (Plate 10). This last feature is important as the densest cluster of extant apple trees—in their early/original orientation—is located the north of the former road and south of the circular driveway in front of Assembly Hall.

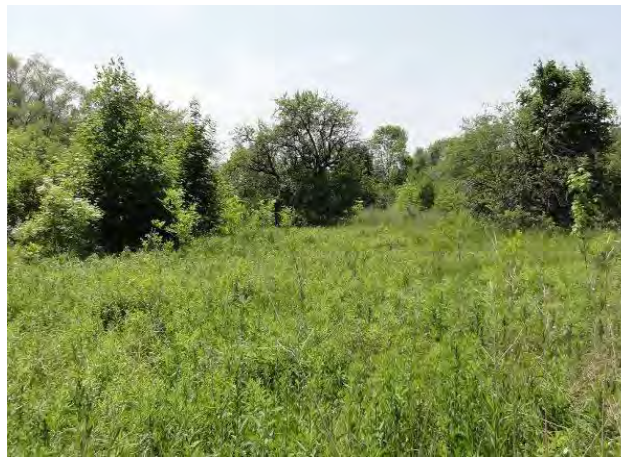
Plate 4: Grassy meadow in middle of southern half of wooded area. Note apple tree in centre. View to northwest. (Photo taken in 2011)

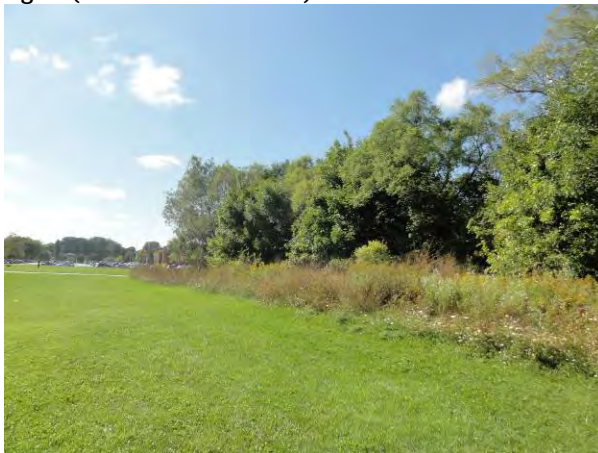
Plate 5: West-northwest view of mature deciduous trees along the southern boundary of the orchard. (Photo taken in 2014)

2. Site plans should be reviewed to investigate the feasibility of retaining the most significant of the mature trees located along the south edge of the grassy setback along Lake Shore Boulevard West. In particular, the Red Oak tree located at the northwest corner of the study area (identified as #704 in the Arborist Report prepared in 2013 by The MBTW Group) and the cluster of Sugar Maples in the centre of the wooded area (identified as #651, 652 and 657-661 in the Arborist Report prepared in 2013 by The MBTW Group) should be considered for retention if possible. If necessary, selective culling of the younger, less-established plantings may be considered following the advice of a qualified arborist;

3. If the retention of the mature trees located along the south edge of the grassy setback of Lake Shore Boulevard West is not possible, then a post-construction landscape plan should be created to preserve and/or rehabilitate these mature deciduous trees. Where feasible, impacted vegetation should be replaced in kind to preserve the wooded nature of the site. New plantings should match the old in species, color, and texture. New vegetation should ensure that the heritage value of the property is preserved and supported;

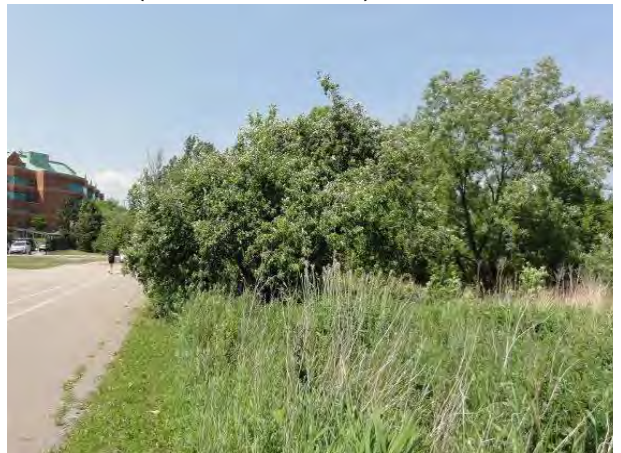
Plate 6: Willow trees bordering North Creek. View from south. (Photo taken in 2011)

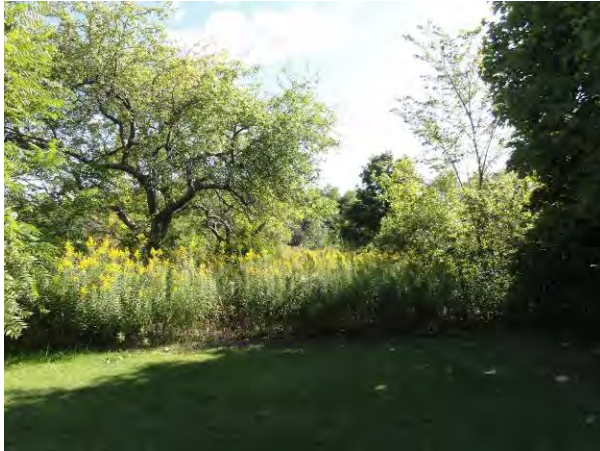
Plate 7: South-southeast view along the alignment for North Creek. (Photo taken in 2014)

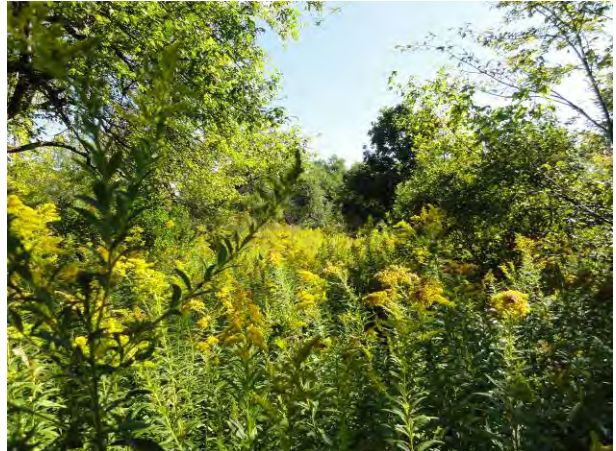
Plate 8: Close-up of the alignment of North Creek. The creek was not visible due to heavy vegetation cover. (Photo taken in 2014)

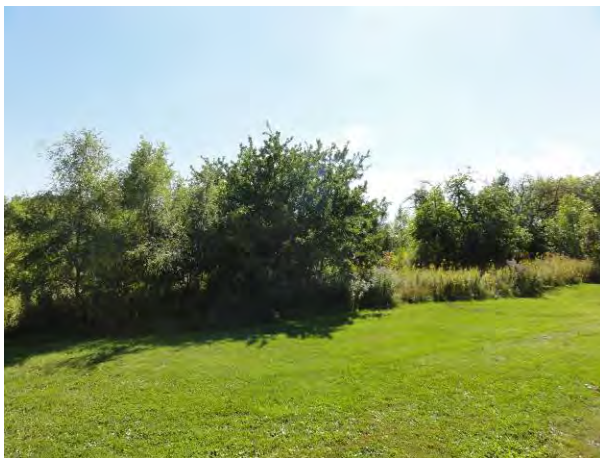
Plate 9: South-southwest of the original orchard on the south side of the east-west axial path. (Photo taken in 2014)

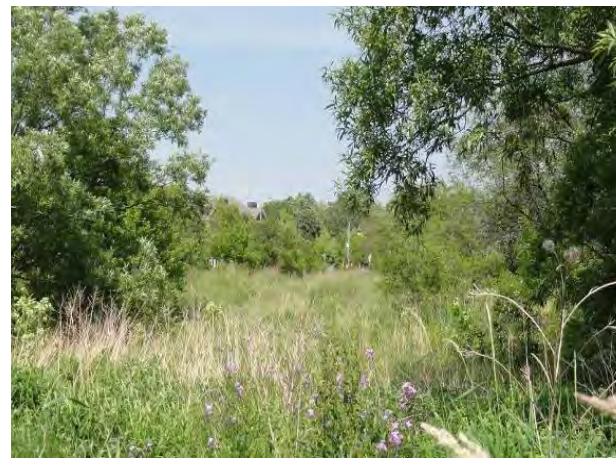
Plate 10: Remnants of access road to marina. View across southern half of wooded area looking northeast. (Photo taken in 2011)

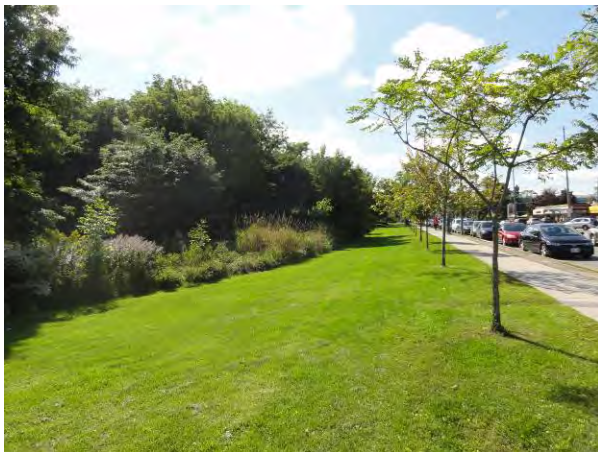
This section of the study area extends north from the east-west axial path to the grassy setbacks running along the south side of Lakeshore Boulevard West (Plate 11). Mature deciduous trees are planted along the south edge of the grassy setback along Lakeshore Boulevard West. Somewhat larger than the south half, the northern section measures approximately 115 metres (east-west) by 135 metres (north-south). The extant concentration of fruit trees, however, covers a much smaller area. A small section which extends c. 35 metres east of the western limits and which extends south down to the path creates a ‘jut’ (Plate 12) into the grassy area bordering the north side of the axial path. This strip is densely covered with scrub vegetation and small trees. The ground level here is slightly lower than the western section which slopes slightly upward to higher ground along the axis of the ‘jut’. A review of contemporary aerial photographs shows that some of these plantings run along what would be the continuation of North Creek. No above ground evidence of this creek was noted in the northern section.

Plate 11: West-southwest view along Lakeshore Boulevard West. (Photo taken in 2014)

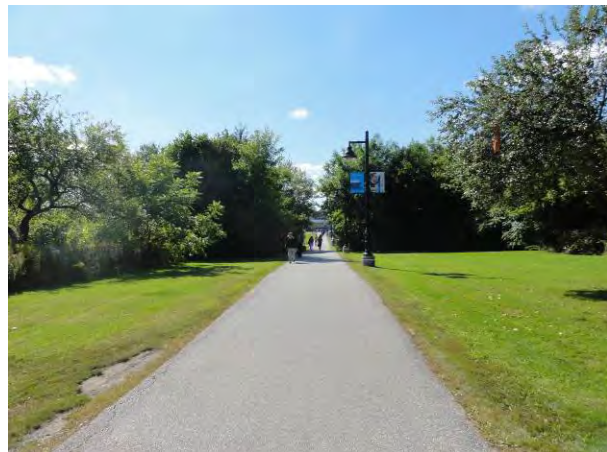
Plate 12: West-southwest view along the east-west axial path. Note the “jut” at the end of the path. (Photo taken in 2014)

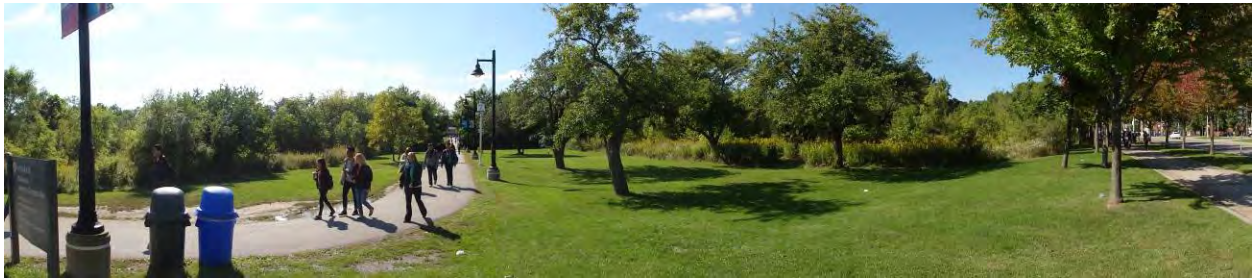
Plate 13: West-southwest view of the historic orchard on the north side of the east-west axial path. Note the rows of apple trees on the right. (Photo taken in 2014)

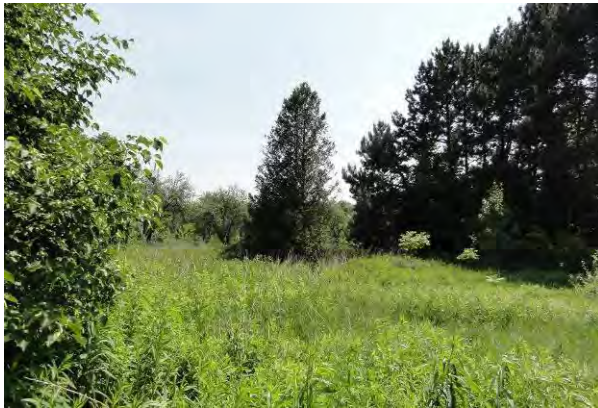
Plate 14: Open space in north wooded area. Line of apple trees visible in background, behind larger coniferous tree. View to southwest. (Photo taken in 2011)

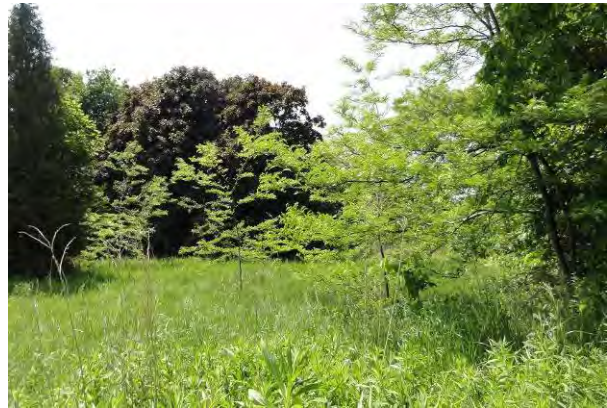
Plate 15: View across north wooded area to mature plantings along set back bordering Lakeshore Boulevard West. (Photo taken in 2011)

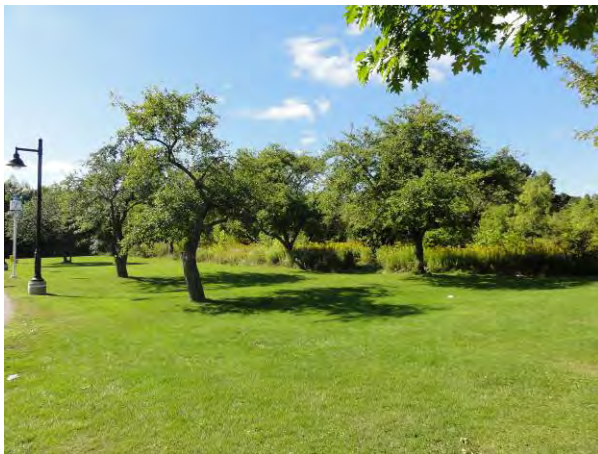
Four clear rows of apple trees and at least two more, less distinct, rows running north from the east-west axial path were identified (Plates 16 and 17). All of these were also identified south of the east-west axial path. The rows in the north half of the orchard are far more substantial with rows made up of at least two adjacent trees and ranging to a line of up to five trees. The identified ‘rows’ south of the east-west axial path of single trees represent a continuation of five of the six identified rows.

Plate 16: West-northwest from the east-west axial path. Note the rows of apple trees. (Photo taken in 2014)

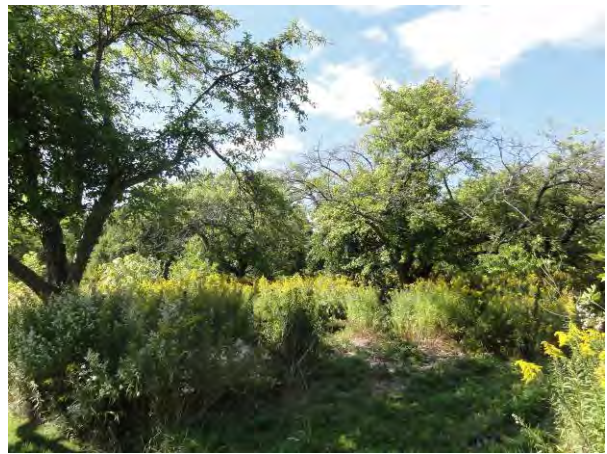
Plate 17: Northwest view into the rows of apple trees located on the north side of the east-west axial path. (Photo taken in 2011)

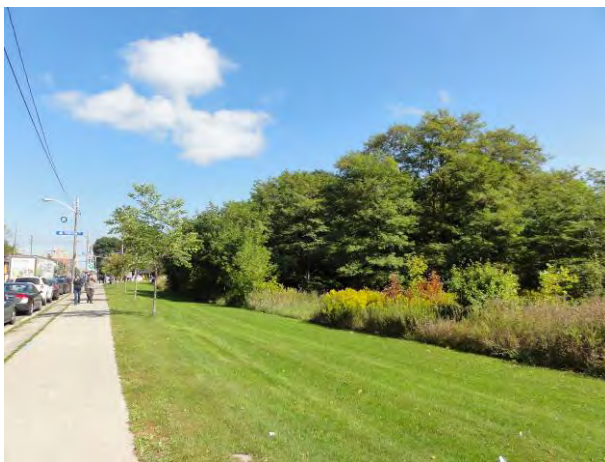
Plate 18: East-northeast view along Lake Shore Boulevard West. Note the grassy setback and mature trees. (Photo taken in 2014)

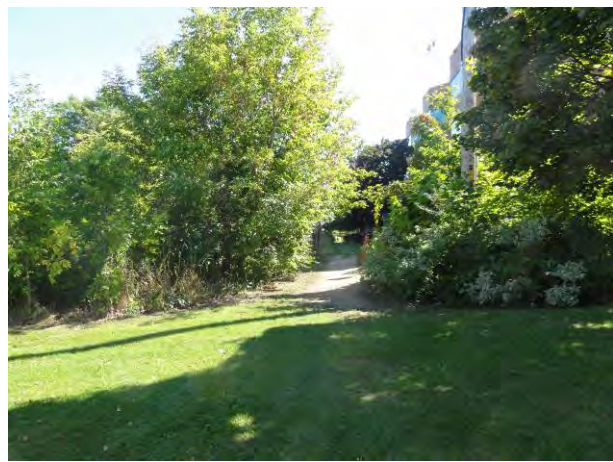
Plate 19: South-southeast view along the pathway along the western edge of the orchard. Lakeshore Lodge is located on the right. (Photo taken in 2014)

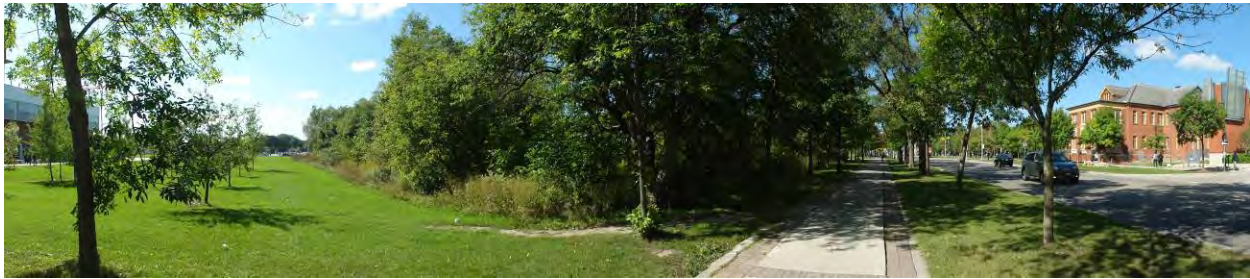
Plate 20: Northwest view of the southern limits of the orchard. Note the grassy area associated with Father John Redmond Catholic Secondary School on the left and Colonel Samuel Smith Park Drive on the right. (Photo taken in 2014)

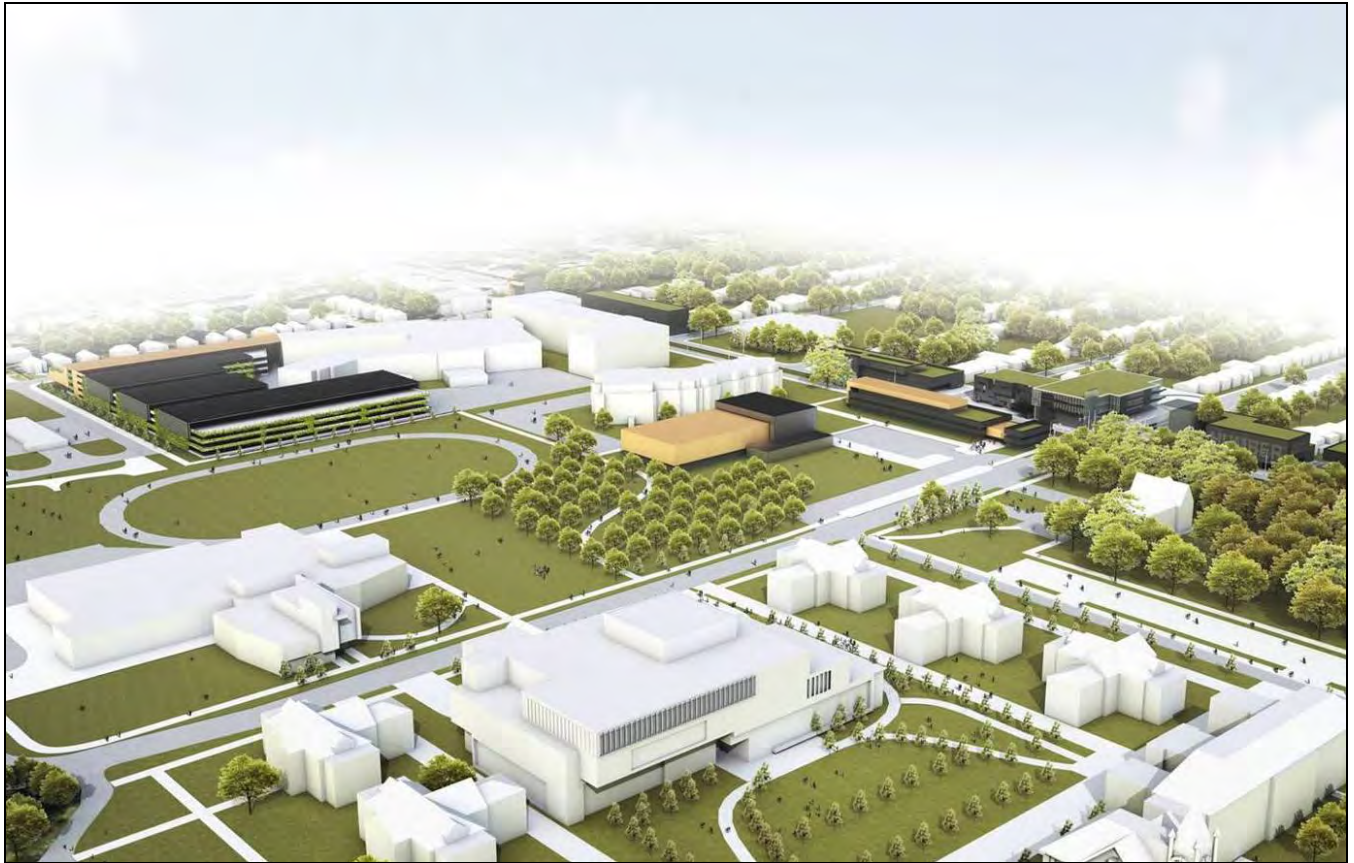
Figure 28: Third Rendering of Proposed Development (Humber College, June 2011). New structures depicted in black and yellow. View to the northwest.

Plan 3, June 2011 (Figure 28)

- The proposed 'Welcome Centre' has the potential to impact upon the cultural heritage landscape made up of the line of mature trees bordering the setback along Lakeshore Boulevard West. Potential impacts in this instance would be caused through destruction or alteration of any or part of any significant heritage attribute or feature (III.1 and III.2). Depending on the final location and extent of this structure and/or associated features which may include parking lots or pathways, the proposed development may also have the potential to impact individual apple trees.
